## **Updated Environmental Management Plan (EMP)**

**The Operations and Maintenance of the Existing 3-Megawatt (MW) Solar (Photovoltaic (PV)) Park within the Townlands of Arandis, Erongo Region –  
Application for the Renewal of an Environmental Clearance Certificate (ECC)**

**APP-005933**

**June 2025**

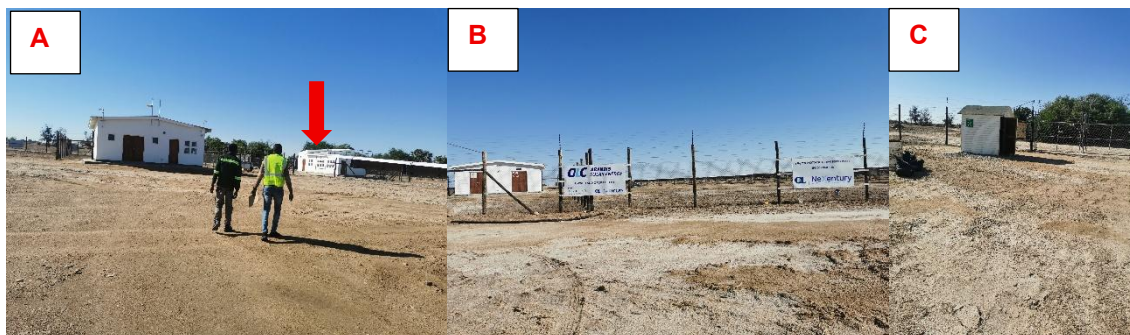
**Figure 2-1: A - The site office (western part of the administrative building) with the Training Centre pointed by the red arrow, B – OLC Transfer Station (eastern side of the administrative building), and C - the security control room at the site gate**

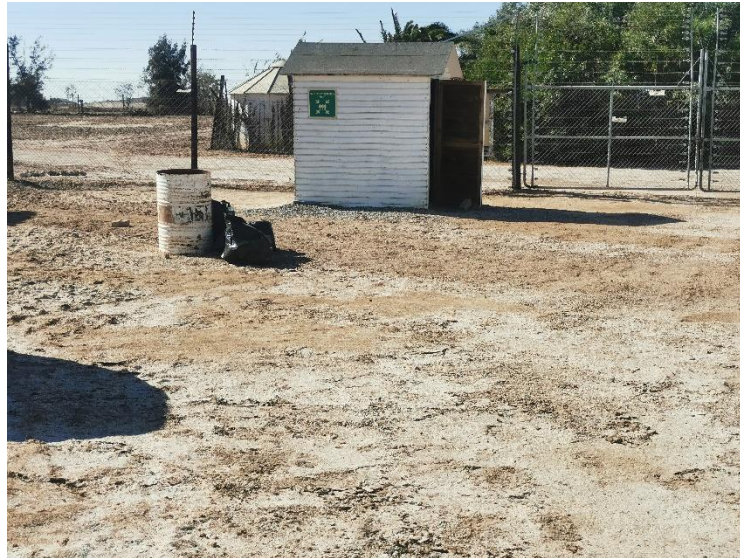
**Figure 2-2: Central solid waste collection point onsite (drum and refuse bags awaiting collection by the Arandis Town Council)**

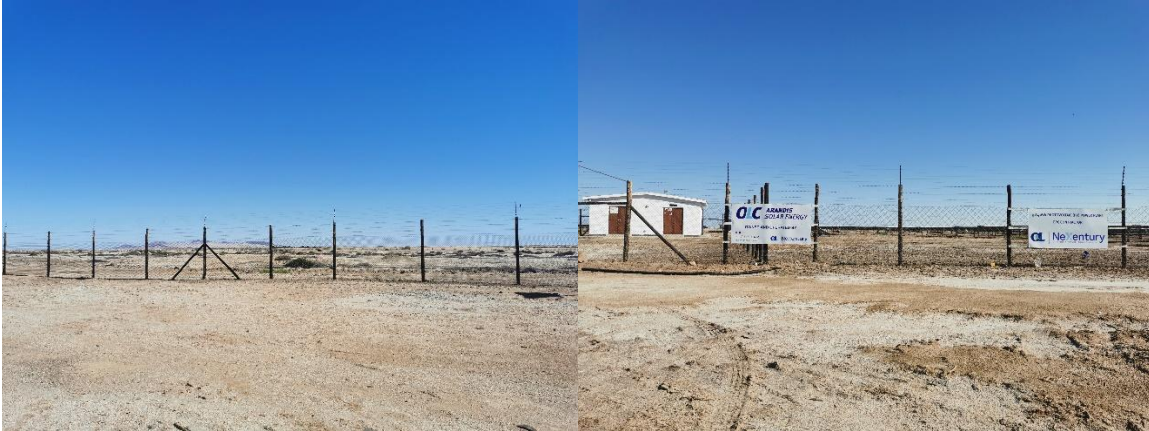
Apart from the security guards, the project site is well fenced off, with animal-proof wire on the outside and an electrical fence on the inside - Figure 2-3. The fencing is aimed at keeping animals out and preventing the theft and vandalism of the site infrastructure. The electrical fence is connected to a security alarm system that reports to the Plant Operator's phone in the event of a loss of power or breach.

**Figure 2-3: The meshed electric security fence around the Site**

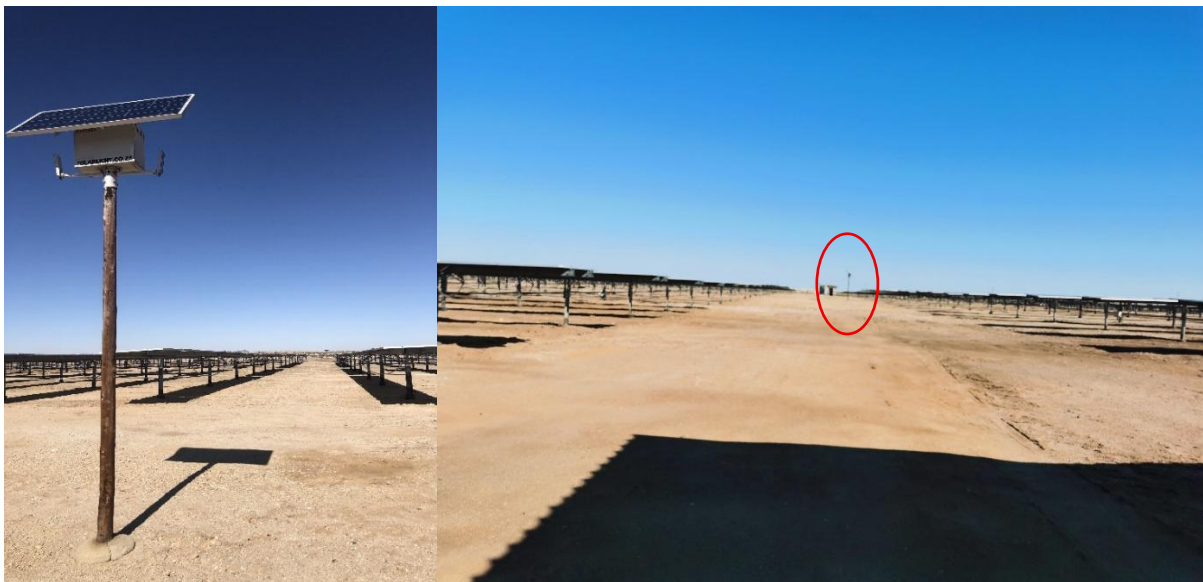
**Figure 2-4: Some of the self-powered spotlights that are onsite**

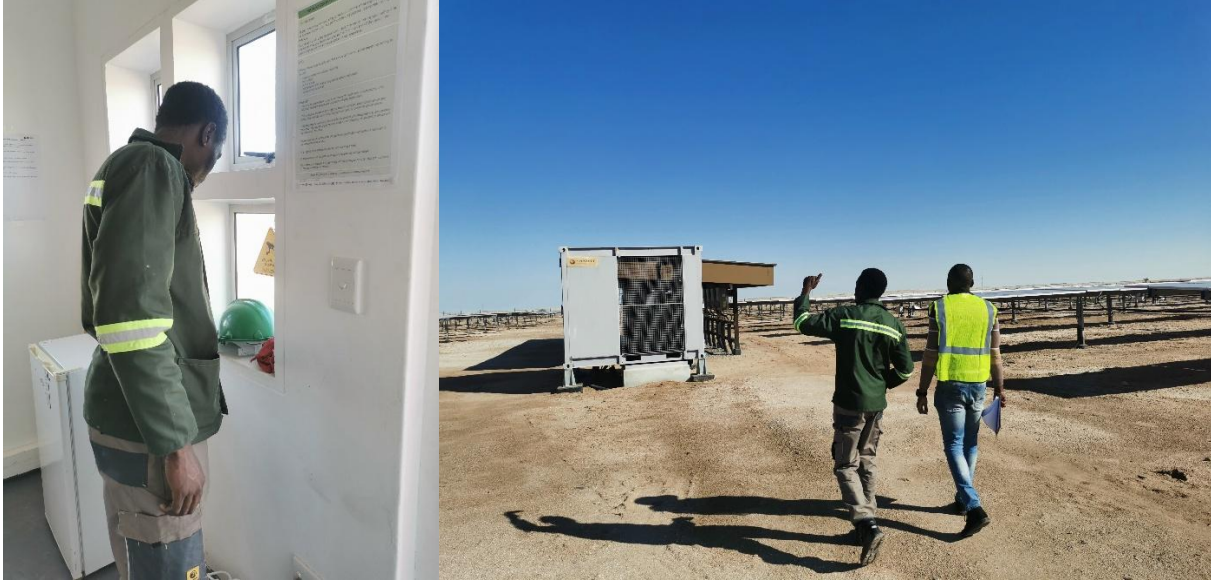
All project workers are equipped with appropriate and adequate personal protective equipment (PPE) - Figure 2-5. For minor occupational injuries, there is a first aid kit onsite, and major ones are referred to health facilities in Arandis and or Swakopmund, if necessary.

**Figure 2-5: The Site operator with PPE and Serja HGE Consultants personnel onsite**

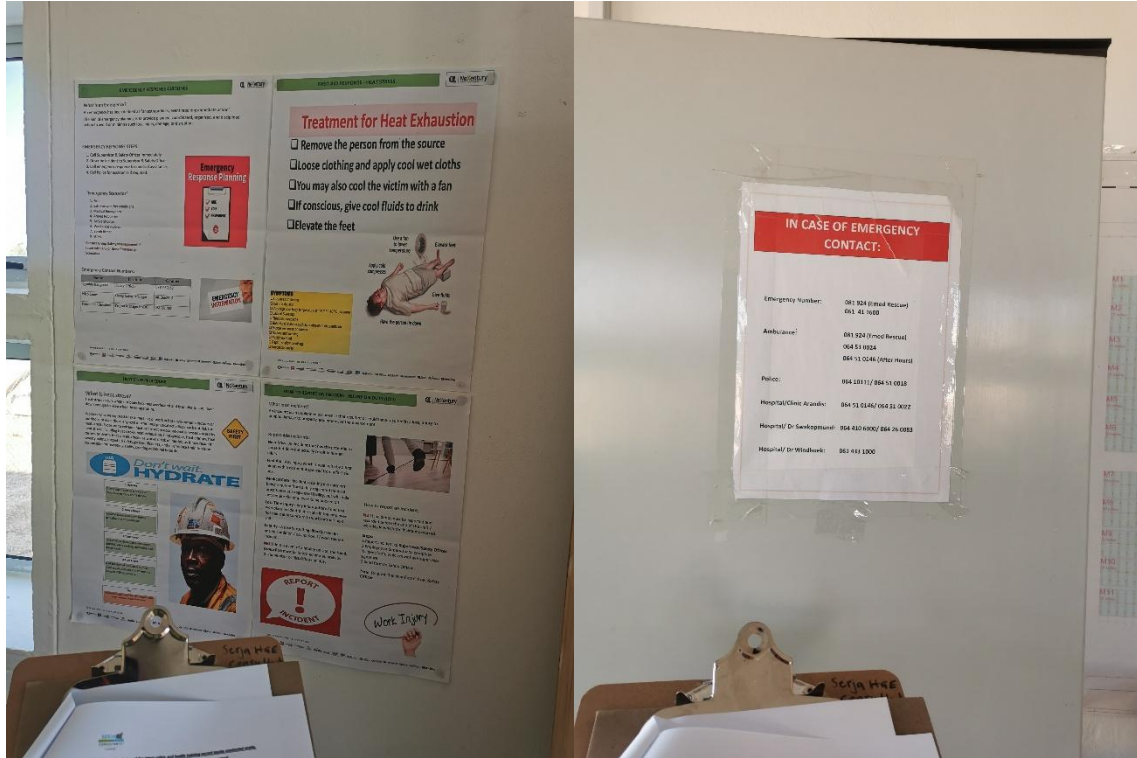
Moreover, there are emergency response guidelines as well as first aid response (such as heat stress) as well as emergency contact numbers displayed on the office wall - Figure 2-7.

Figure 2-7: The emergency response guidelines and contact numbers

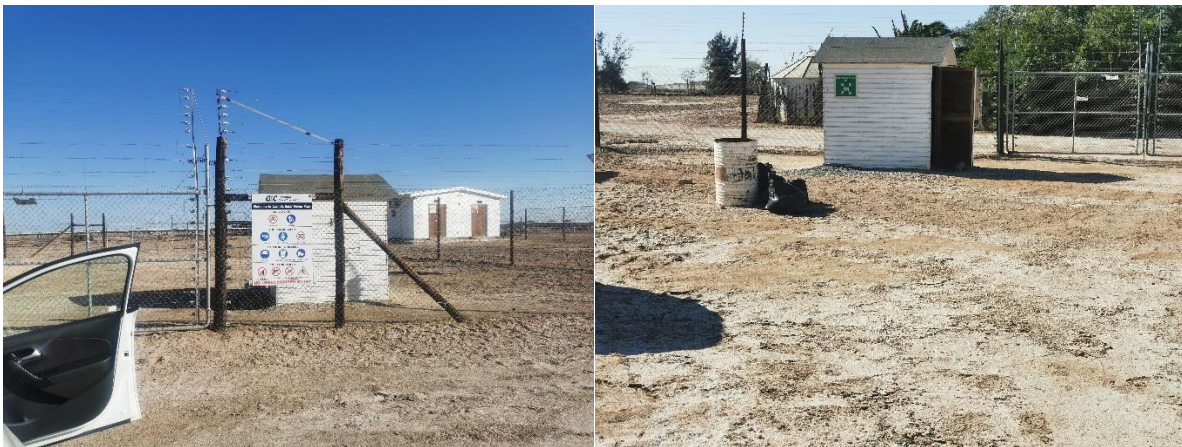
Warning and safety signage: There are warning or cautionary signs onsite, such as the speed limit, PPE and vehicle requirements, and assembly point markings at the site entrance (Figure 2-8).

Figure 2-8: The warning and safety signs (including the assembly point sign) at the Site gate

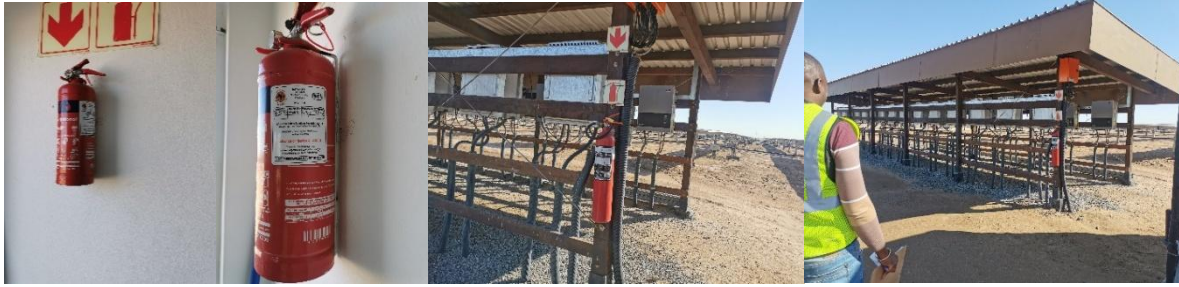
A. The site has four fire extinguishers (one for the office, one in the transformer room, and two at the inverter area). The extinguishers are well-serviced with the next service due in August 2025. Photos of the fire extinguishers in the Site office and at the substations are shown in Figure 2-9.

Figure 2-9: Some of the fire extinguishers at the Site (in the office and at the substations)

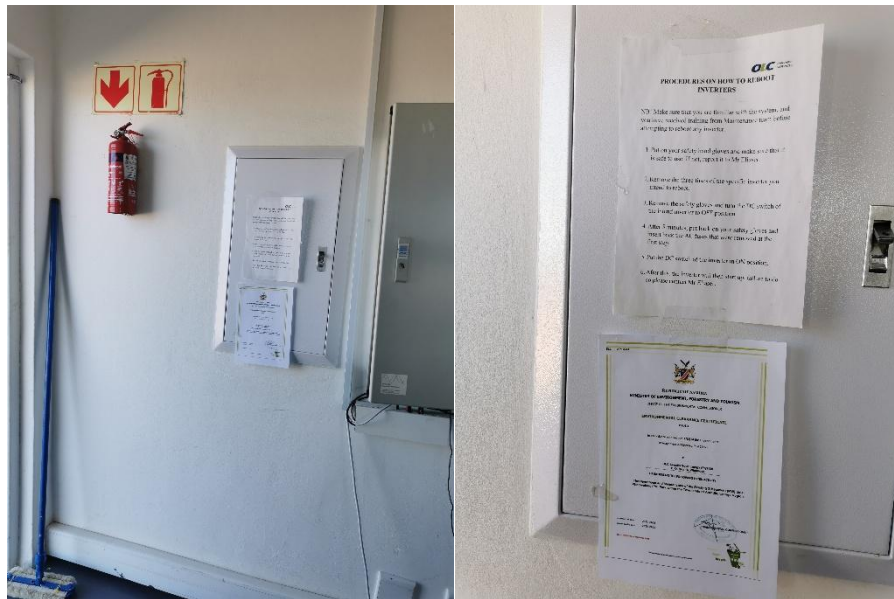
The site activities are all environmentally cleared, and the ECC was issued on the 26<sup>th</sup> of September 2022 and is valid until the 26<sup>th</sup> of September 2025. The copy of the ECC is pasted in the administration building, as shown in Figure 2-10. To ensure that the ECC remains valid after the 3-year validity period, the ECC renewal application is submitted with the updated EMP to the Environmental Commissioner in June 2025 to allow time for the evaluation of the application for renewal consideration.

Figure 2-10: The copy of the valid ECC in the Site Office

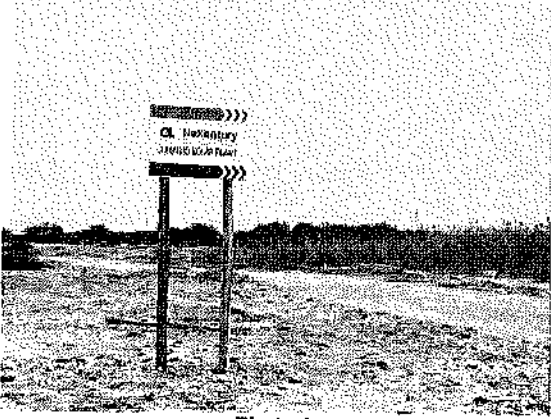
<p>Photo 1.</p>	<p>New site signage erected but arrows pointing in the wrong direction. Sign either needs to be replaced or place on another location to accurately indicate direction.</p>

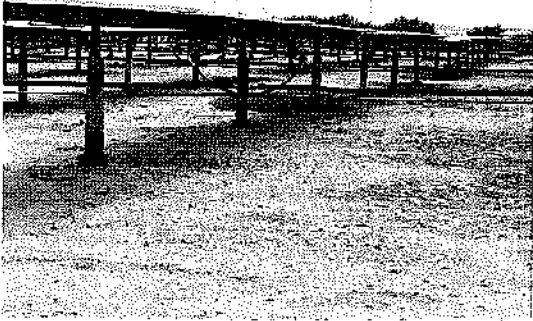
<p>Photo 2.</p>	<p>Some vegetation can be observed, but generally is not an operational concern at this stage. Will need to monitor vegetation growth. Herbicide application should be <u>avoided</u>.</p>

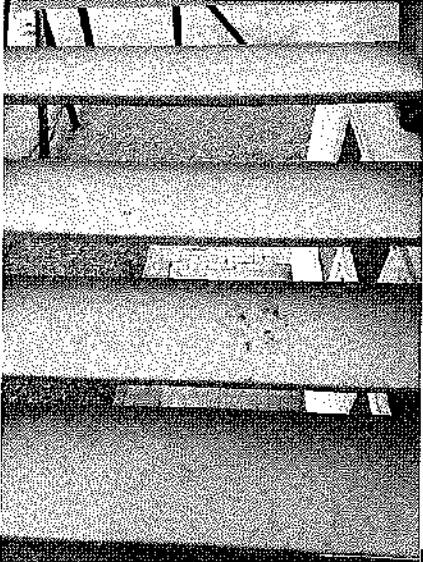
<p>Photo 3.</p>	<p>Some rust and degradation observed on steps. Need to be monitored to ensure it does not become a safety concern.</p>

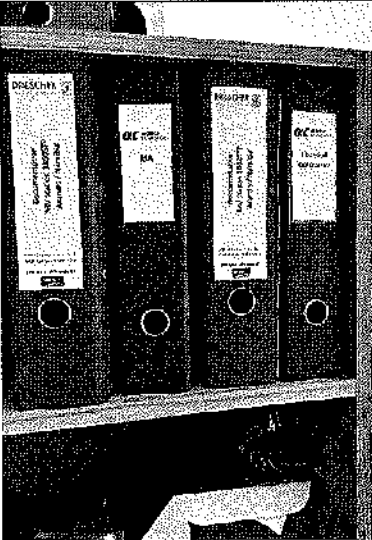
<p>Photo 5.</p>	<p>EIA file available on site, but should be updated to include all EMP related information as well.</p>

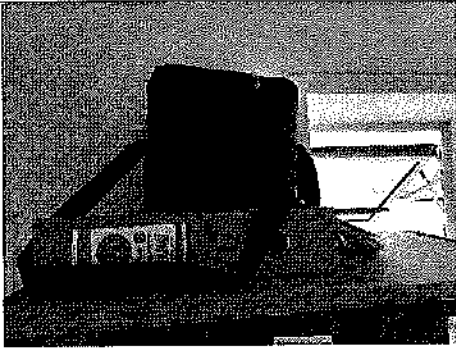
<p>Photo 6.</p>	<p>First aid box available on site.</p>

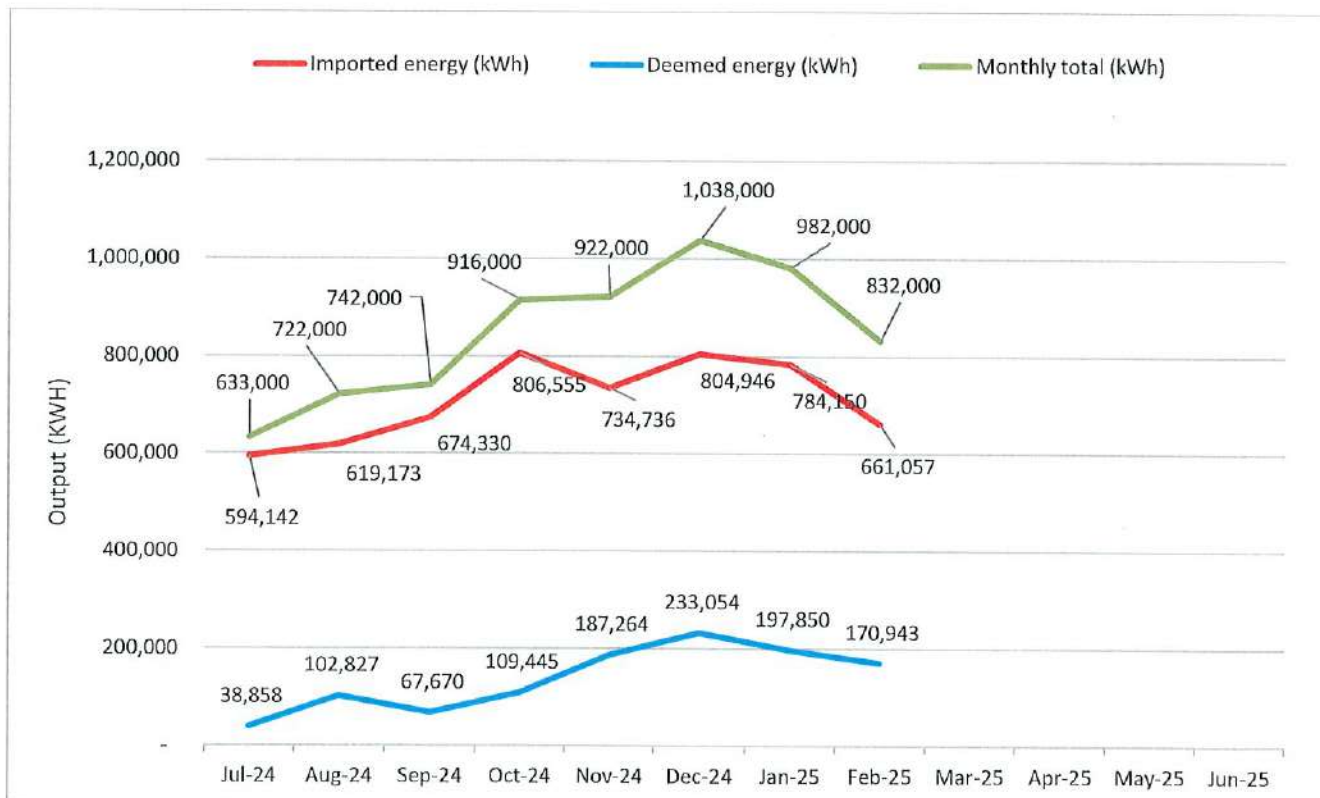
**Figure 2. Monthly solar output (kWh) for July 2024 to date (J Huisamen, 2025)**

Please see figure 2 below for an overview of the monthly output readings for the plant for the F25 financial year.

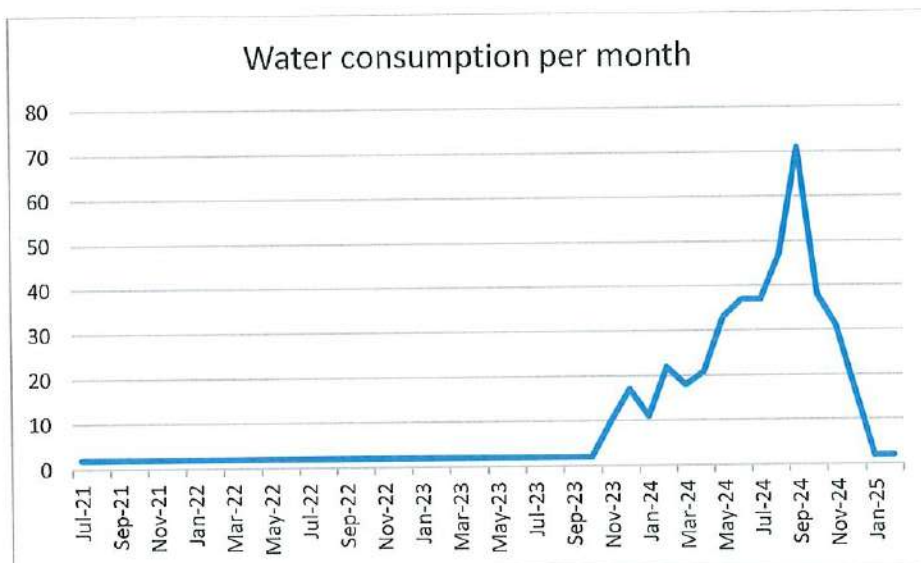
Figure 6. Monthly water consumption at the site as from July 2021 to date

**March 2023:** More can be done to communicate need for improved resource stewardship. Data needs to be maintained for water consumed on site.

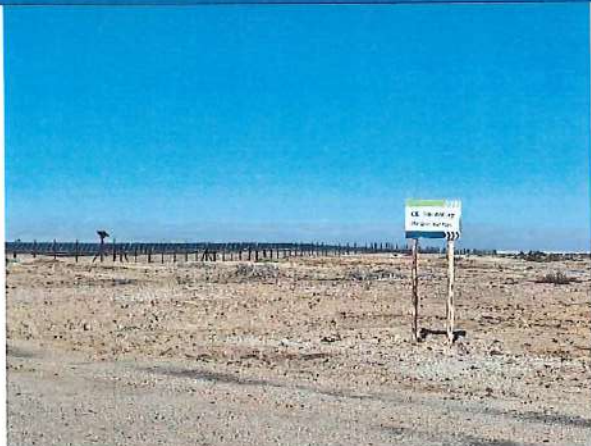
<p><b>Photo 1.</b></p>	<p><b>Date of photo: 1 March 2025</b></p> <p>New signboard erecting still pointing the wrong way. Not clearly visible at a distance.</p>

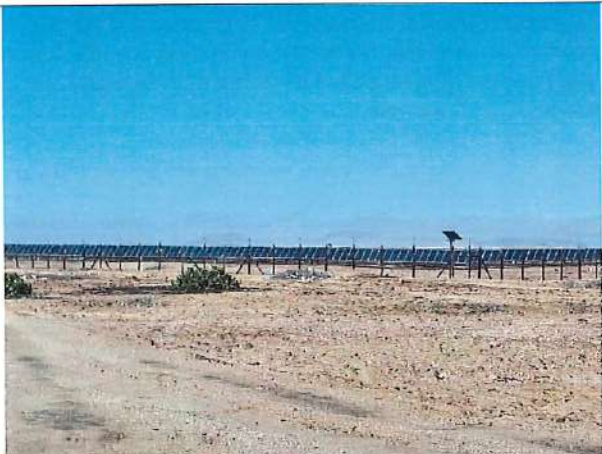
<p><b>Photo 2.</b></p>	<p><b>Date of photo: 1 March 2025</b></p> <p>Generally low visual impact observed from the road site. Development "blends" well with surrounding environment and no complaints received to date regarding glint or glare.</p>

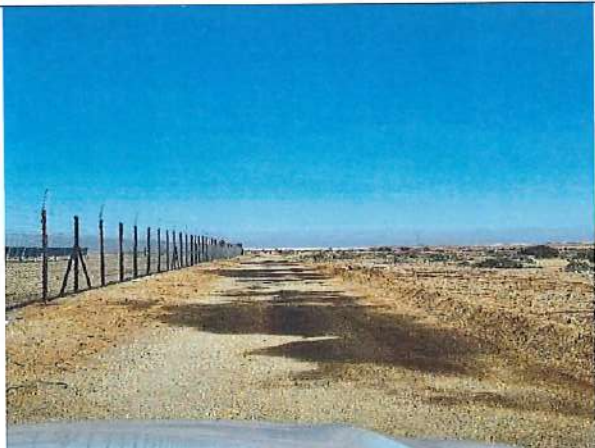
<p><b>Photo 3.</b></p>	<p><b>Date of photo: 1 March 2025</b></p> <p>Some evidence of a significant oil spill in the access road which runs past the site. This was never previously observed during inspections, and it is unlikely that this was caused by any activities executed on site.</p> <p>This road is also used by vehicles traveling to the waste disposal facility and it is more likely that the cause of the spill can be found there.</p>

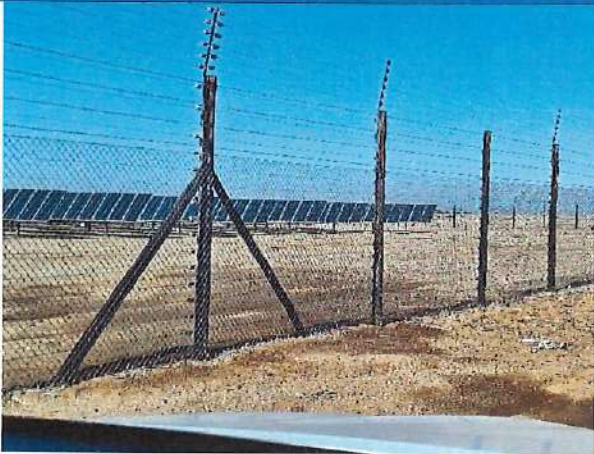
<p>Photo 4.</p>	<p><b>Date of photo: 1 March 2025</b></p> <p>It does, however, appear as if the spill has spread into the boundaries of the site.</p>

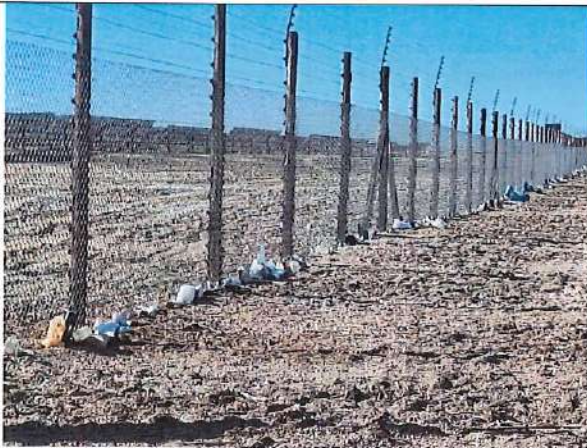
<p>Photo 5.</p>	<p><b>Date of photo: 1 March 2025</b></p> <p>Poor management of the town dump site remains a concern as the litter continuously is blown onto site or against the outer boundaries of the site, causing quite an eyesore in the area.</p>
