IRRIGATION SYSTEM FOR AN AGRICULTURE PROJECT ON FARM GAI KAISA NO. 159, OTJOZONDJUPA REGION, NAMIBIA

PROJECT NUMBER: ECC-118-579-REP-02-D

REPORT VERSION: REV 02

DATE: 13 FEBRUARY 2026

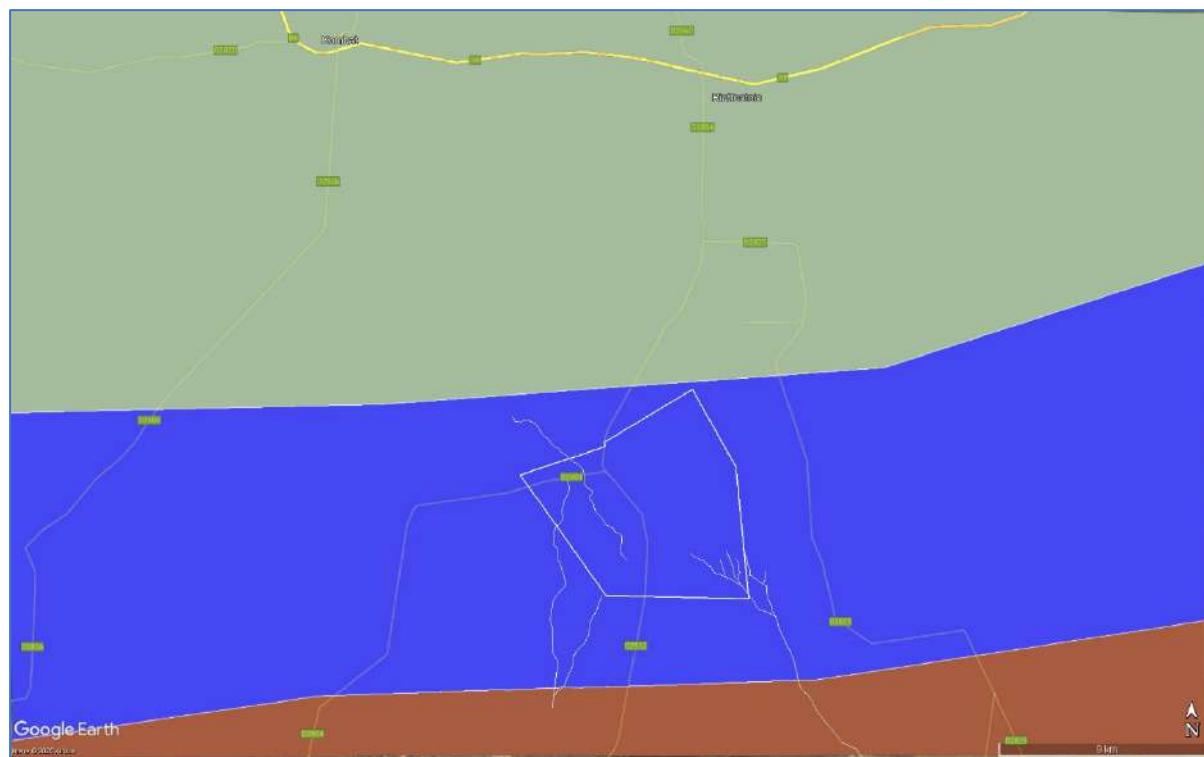
Figure 3 – Mean Annual Precipitation map for Farm Gai Kaisa (blue band = 450 – 500 mm/a)

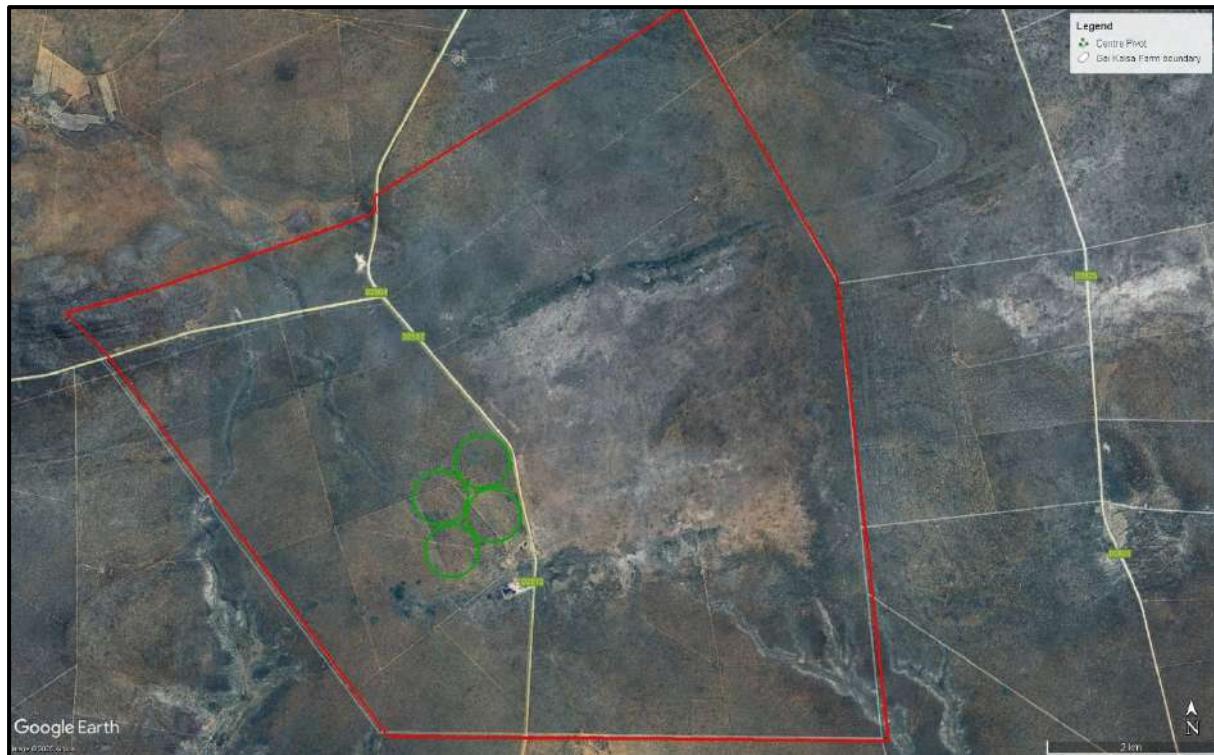
Figure 11 – Area on Farm Gai Kaisa (red polygon) planned for centre pivot irrigation (green circles)

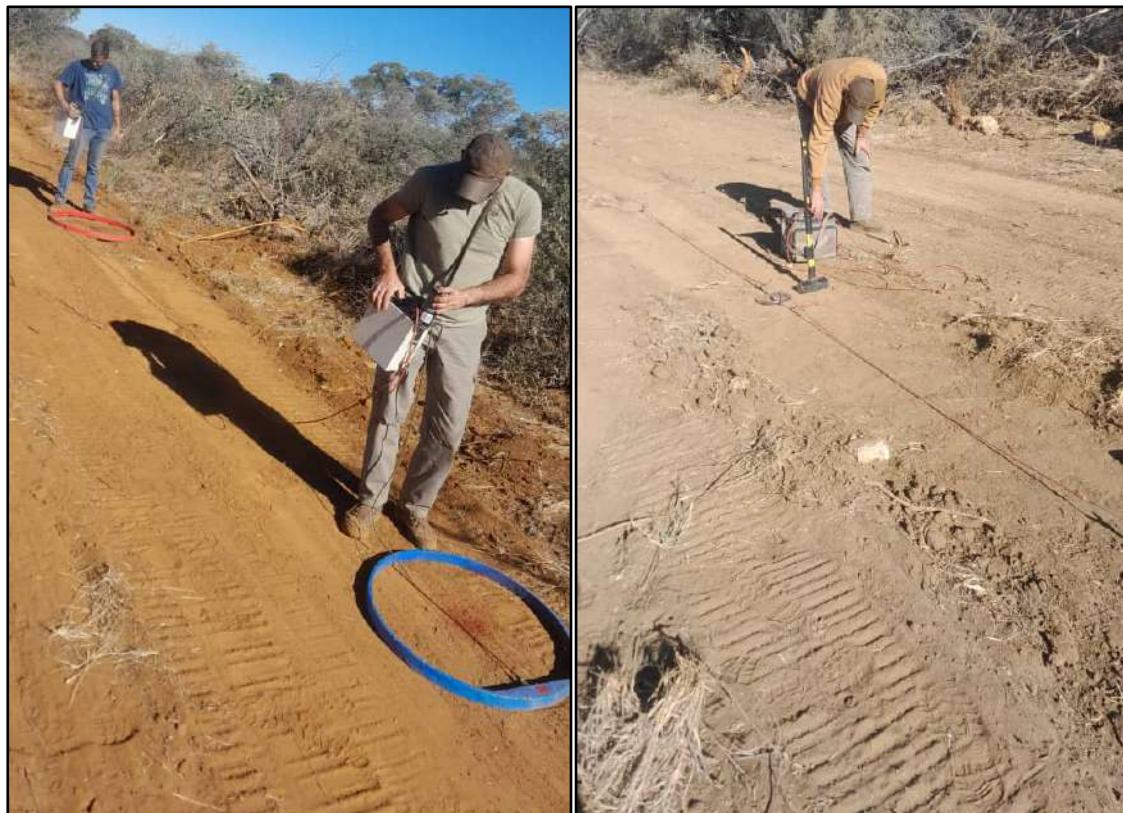
Figure 12 – Photos taken during the EM survey on Farm Gai Kaisa
