**THE ENVIRONMENTAL MANAGEMENT PLANNING (EMP) AND
AUDITING FOR AN EXISTING FUEL RETAIL STATION IN
OTJOURUNDU VILLAGE IN OMAHEKE REGION
TO SUPPORT
THE APPLICATION FOR ENVIRONMENTAL CLEARANCE
CERTIFICATE (ECC)**

Version: Final Draft

APP: 07068

February 2026

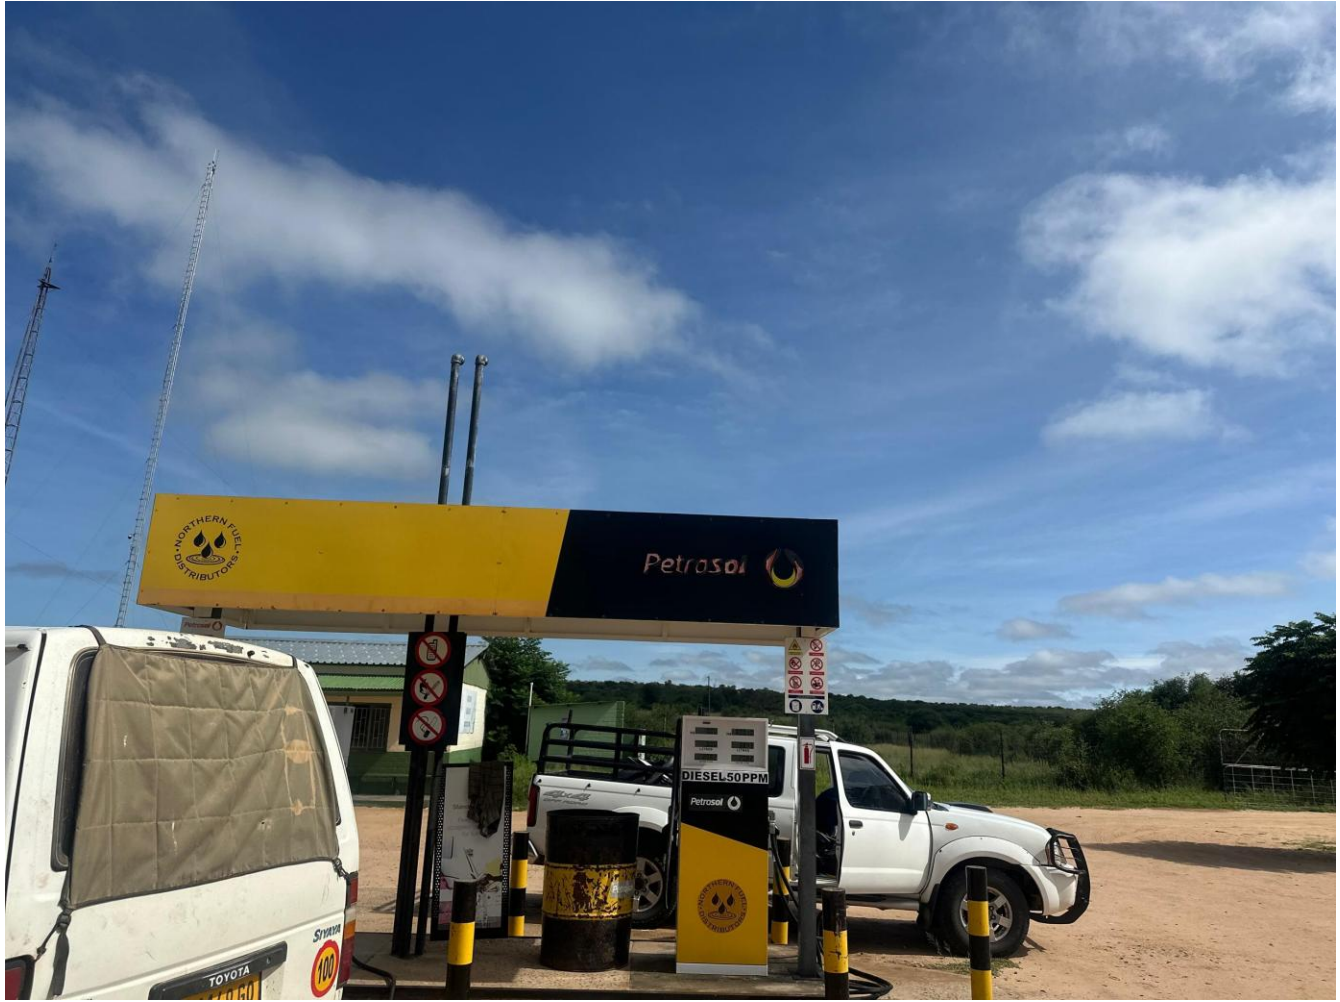
The fuel filling facility comprises buildings that include a reception area, kitchen, toilets, and offices. The remainder of the facility area contains underground storage tanks, fire extinguishers, fire hydrants for emergency control, product pipelines, and a control room for monitoring and controlling product movement. The offloading areas have drainage pits connected to the separator pit for wastewater collection. The stored fuel consists of 50 ppm diesel and unleaded petrol (ULP).

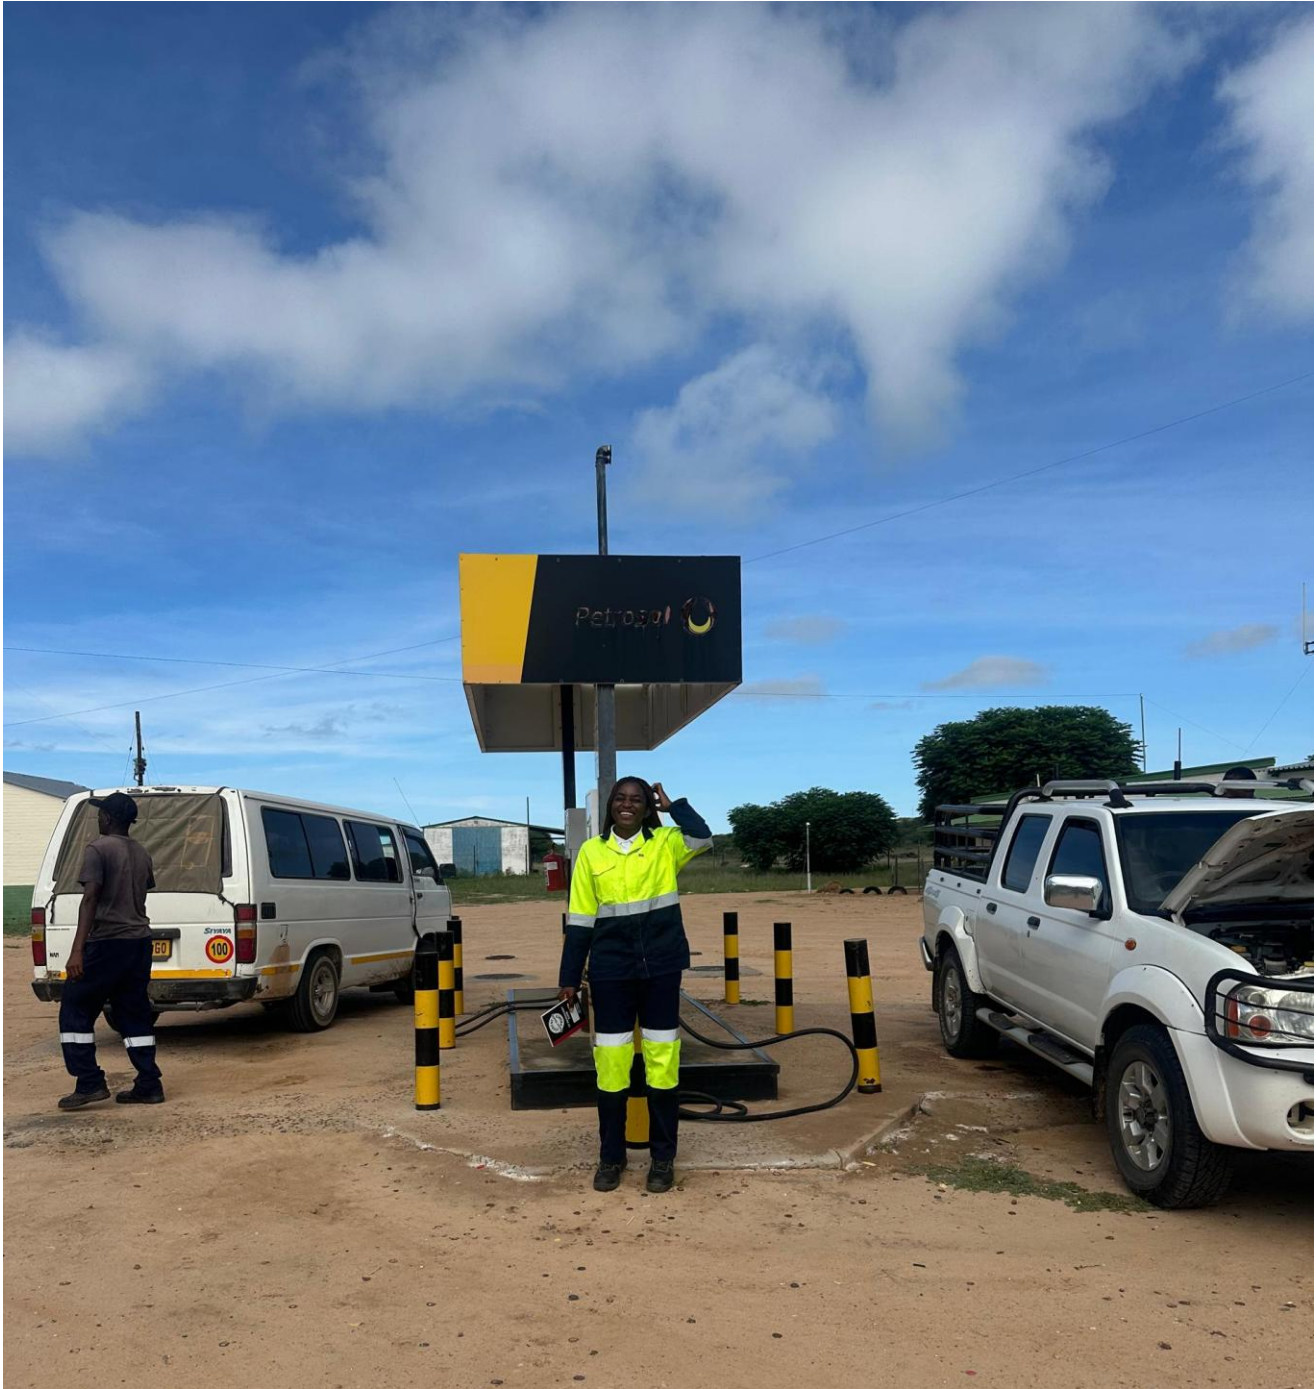
Figure 2 Some of the fuel retail facility areas

No major pools containing liquids likely to be hazardous substances or petroleum products were observed or reported on or adjacent to the fuel retail station facility but there is an evidence of oil spill on site.

EDS did not observe any areas that appeared to have been filled or graded that would suggest the presence of waste, including, but not limited to, construction debris, demolition debris or other solid waste. No improperly stored solid waste was noted but the dust bin are not cleared marked as to what waste are being stored there .
